### DEPARTMENT OF PLANNING & SUSTAINABILITY

Inspector Name: A. McDyess/E. Emmett/D. Pearson	Date: 4/4/2023		
Owner/Tenant/Contractor: Alan Williams	Phone: 770-354-3392		
Address of Subject Property: 561 Key Rd / 1350 Constitution	District/Zone: 15 081 08 001		
Permit No.: 1245564	NPDES Tracking No. N/A		
Site Visit Purpose:  - Follow-up site inspection after the Zoom appointment It has been confirmed that all the violations from the site visit on 3/28/2023 and the corrective maintenance recommendations made by the inspectors have been corrected and compliance has been obtained.	Compliance/Violation Determination: -BMPs compliance obtained -Silt Fence in the GA Power Easement Area that the protesters damaged/destroyed has been corrected No sediment escape or environmental impacts observedRepairs to all the silt fence and tree protection has been made, the site is in compliance and is environmentally up to DeKalb County Ordinance.		
Notice of violations Issued? No, construction violations were observed.	Stop Work Order issued?

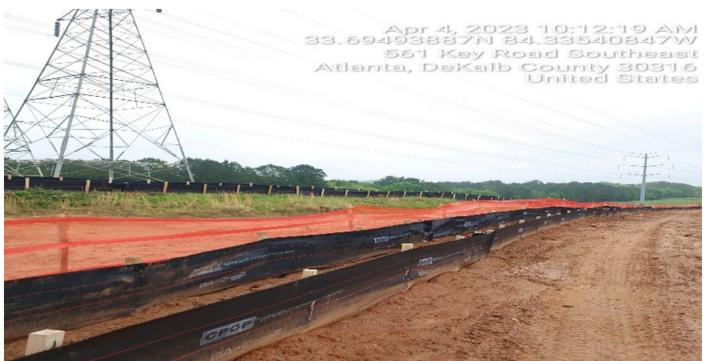
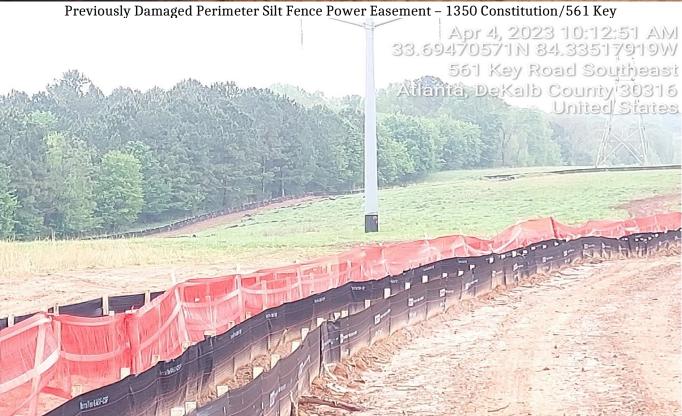
Previously Destroyed Perimeter Silt Fence at Power Easement Area
